# Bridge Inspection Program

## FY 98 Routine Inspections

September 1998

New England District

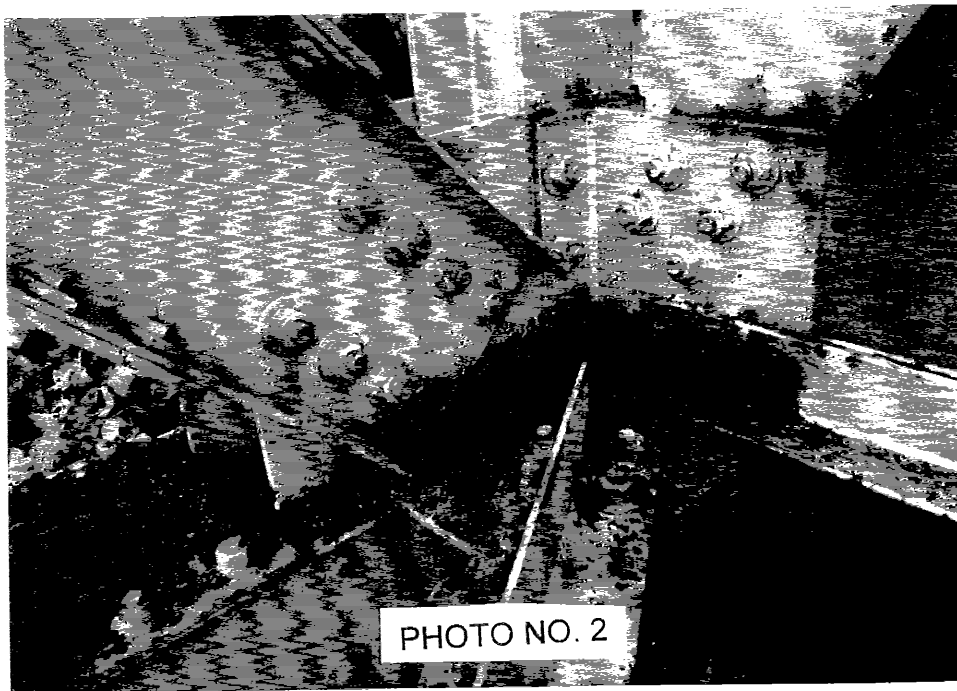
Photo 2 - Lower truss connection above northeast bearing; Note extensive build-up of debris and corrosion.

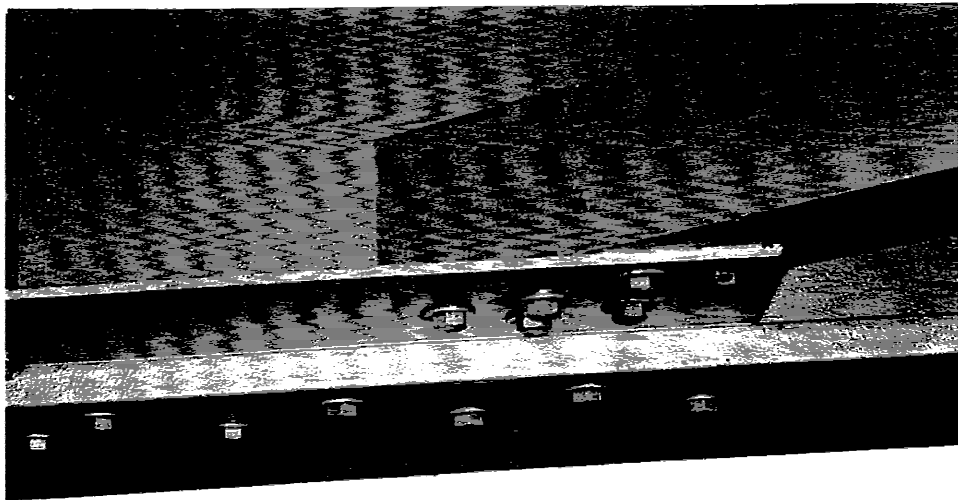
PHOTO NO. 4  
LOOSE WASHERS AND BOLTS IN LATERAL BRACING

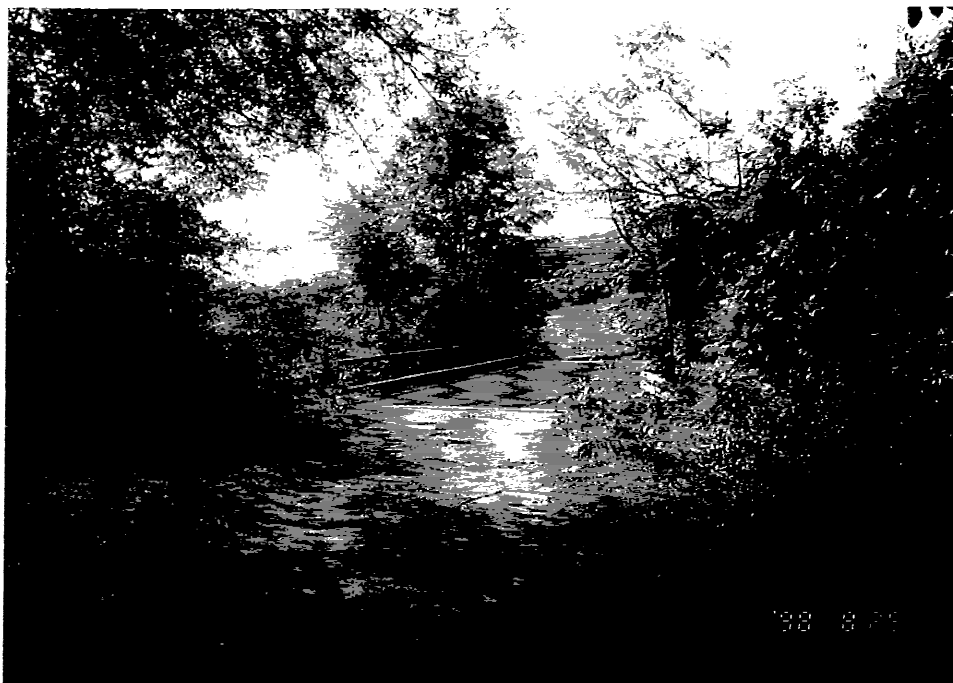
PHOTO NO. 1  
VEGETATION AT NORTH APPROACH

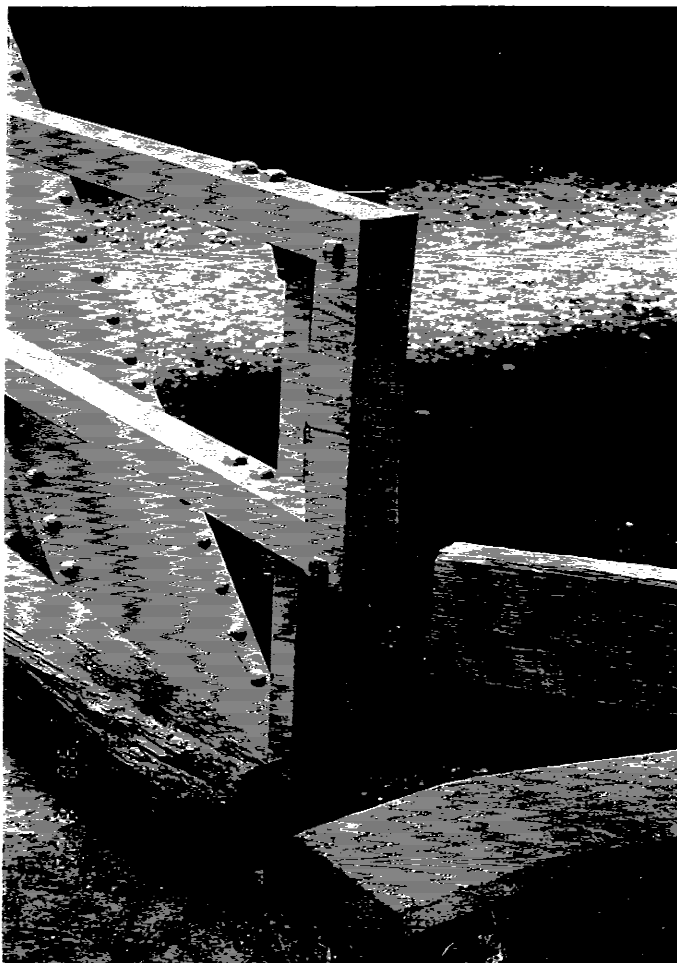
PHOTO NO. 2  
SCRAPED RAIL AT  
NORTHWEST APPROACH

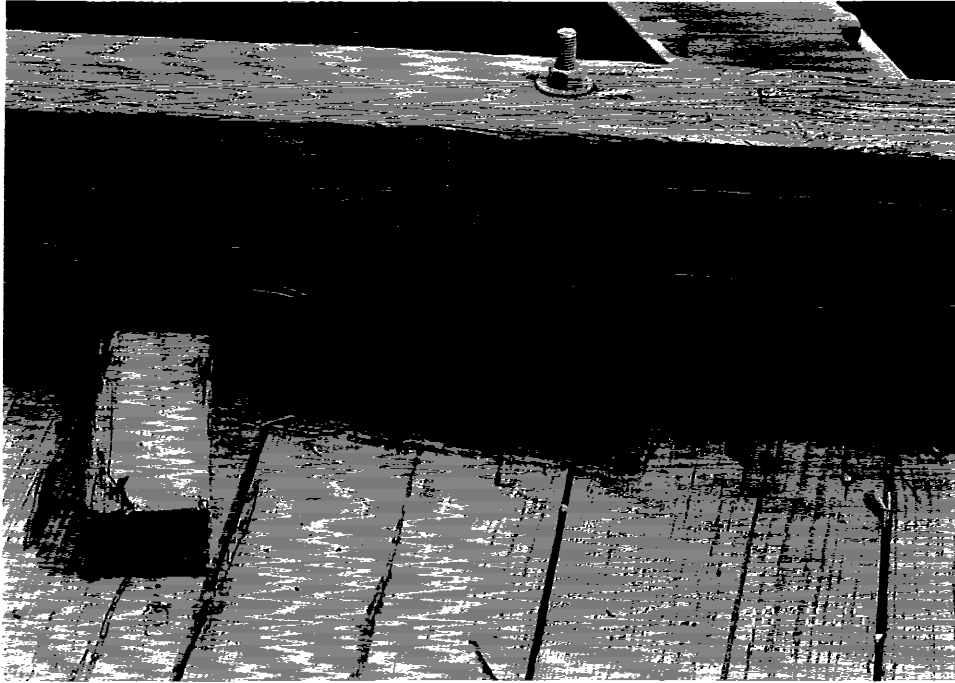
PHOTO NO. 3  
BROKEN CRIBBING BLOCK AT SOUTHEAST CURB
